Home Inspection Report

2214 Gardner Road
Hamilton, Ohio 45013

01:48 May 22, 2008

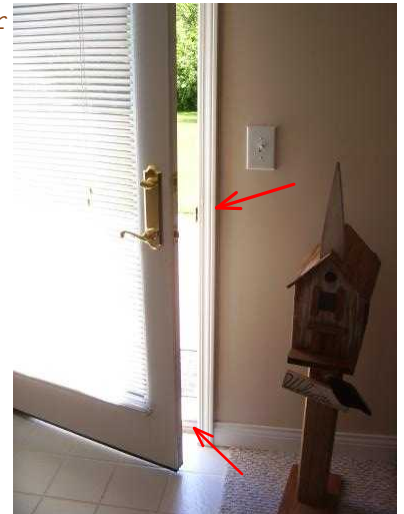
| 7. | <input type="checkbox"/> | <input type="checkbox"/> | <input type="checkbox"/> | <input checked="" type="checkbox"/> | <input type="checkbox"/> | Patio Door: French door, Metal entry door French door to patio needs adjustment to operate properly |

1. **Patio Door:** French door, Metal entry door French door to patio needs adjustment to operate properly
2. **Windows:** Double hung vinyl clad Peachtree thermal insulated Hard operation-needs improvements for ease of operation
3. **Window Screens:** Vinyl mesh, Several screens missing, stored in basement

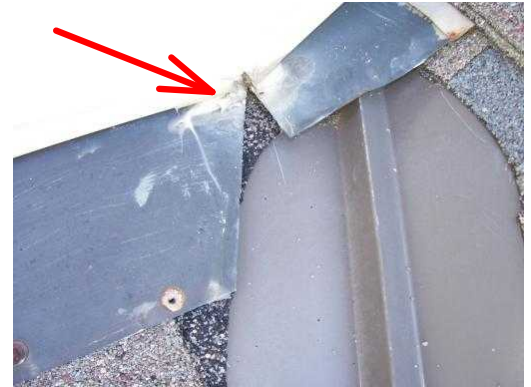
6. Flashing: Galvanized, tern metal *Prone to possible leaks*

4. **Flashing:** Galvanized, tern metal Prone to possible leaks
5. **Plumbing Vents:** PVC Plumbing vent flashing has failed. Replace vent flashing.
6. **South Chimney Chimney Flashing:** Galvanized, tern metal Loose counter flashing- repair

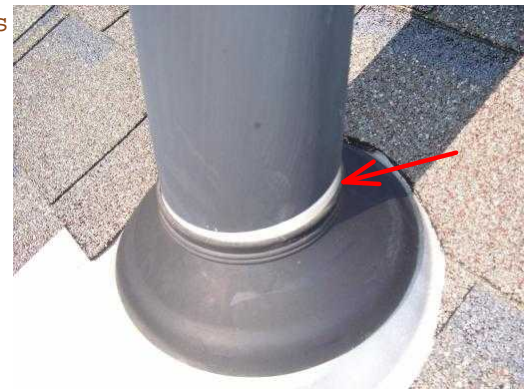
7. Valleys: Preformed metal
8. Skylights:
9. Plumbing Vents: PVC *Plumbing vent flashing has failed. Replace vent flashing.*

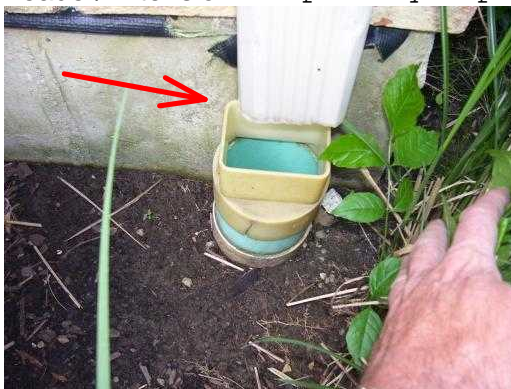
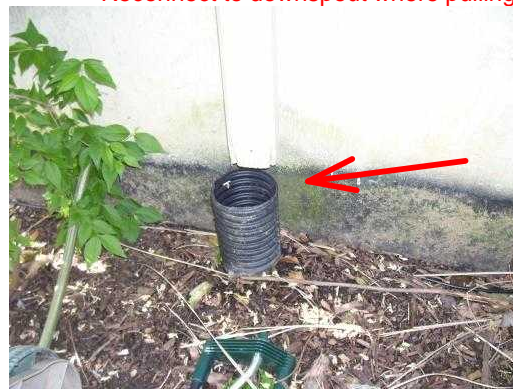
10. Electrical Mast: Underground utilities
11. Gutters: Aluminum
12. Downspouts: Aluminum
13. Leader/Extension: Completely seperated *Reconnect to downspout where pulling loose*

1. Leader/Extension: Completely seperated **Reconnect to downspout where pulling loose**

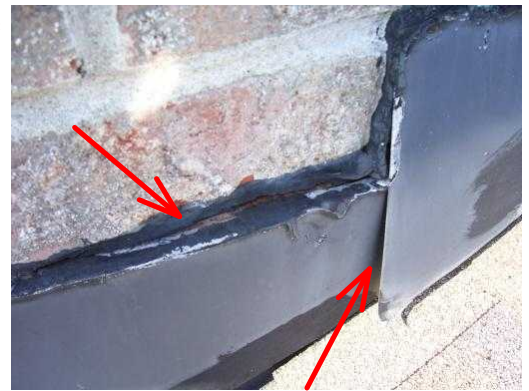
16. Chimney Flashing: Galvanized, tern metal Loose counter flashing- repair

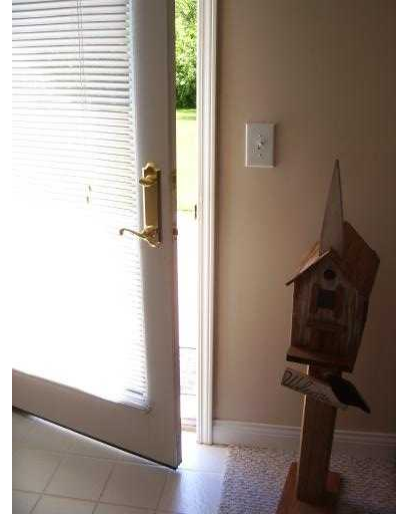
6. Doors: Multi panel hollow core wood The door is sticking, Sill plate needs to be adjusted, Latch plate needs to be re-aligned

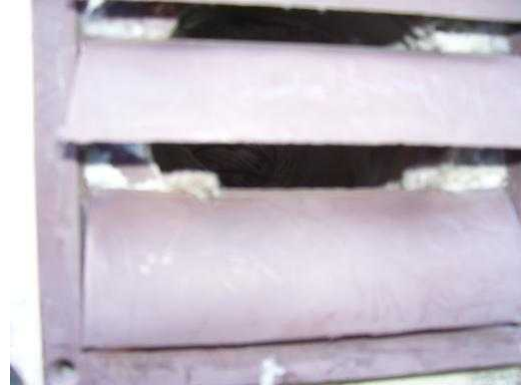
13. Dryer Vent: Plastic flex, Rigid metal Needs cleaning
