Home Inspection Report

2214 Gardner Road
Hamilton, Ohio 45013

01:48 May 22, 2008

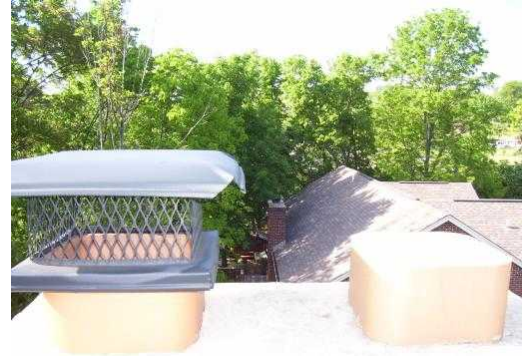
15. Flue/Flue Cap: Clay, Metal/Mortar

16. Chimney Flashing: Galvanized, tern metal Loose counter flashing- repair

<u>Low</u>	<u>High</u>
<u>Roof</u>		
Flashing:	\$ 10	\$ 20
Plumbing Vents:	\$ 20	\$ 30
Leader/Extension: Replace tile leader connector	\$ 10	\$ 20
Chimney Flashing: replace flashing into joint and re-caulk	\$ 20	\$ 50
<u>Basement</u>		
Doors: Minor adjustments	\$ 10	\$ 20
Repair Total	\$ 70	\$ 140
Replacement Total		
Cost Estimate Total	\$ 70	\$ 140

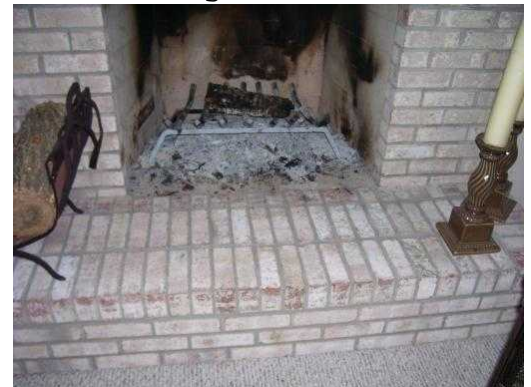
Basement Family / Dining / Bedroom area Living Space _____

37. Closet: Super large utility storage area
38. Ceiling: Drywal ceilings Painted
39. Walls: Painted drywall
40. Floor: Carpet, Ceramic tile
41. Doors: Multi panel hollow core wood
42. Windows: Double hung vinyl clad Peachtree thermal insulated **Hard operation-needs improvements for ease of operation**
43. Electrical: 110 VAC outlets and lighting circuits/ ceiling fans
44. HVAC Source: Air exchange ventilation Full use wood burning fireplace included
